## Upper front control arm bushing **TEDGUM® TED76099** replacement in 5-series BMW (E60) with **TEDGUM® TED99705** bushing puller:

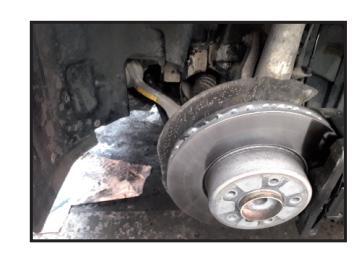
Lift the vehicle and remove a wheel. Afterwards, remove the engine cover which is underneath the car.

The control arm is mounted next to the

then remove the bolt by using a no. 18 socket wrench and a no. 18 wrench.

anti-roll bar. Remove the bolt covers and

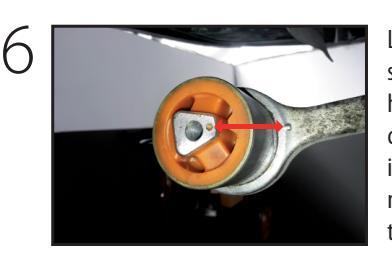
Lubricate the new bushing and control arm socket with isopropanol. The smaller, additional hole in bushing determines the position to the control arm marking. All the markings should be in one line. The correct positioning of elements is necessary for proper forces distribution during the suspension work.

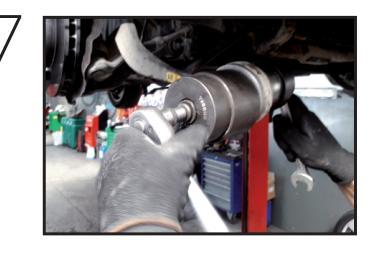
With the use of TED99705 puller and according to the included instruction, press the initially positioned TEDGUM TED76099 bushing in. The bushing should be pressed into control arm socket in the opposite direction to the vehicle engine.

Correctly mounted bushing should be centered in the control arm socket.

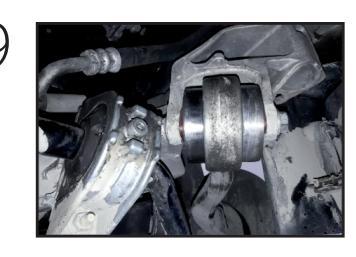
Mount back the control arm and bolt initially. Mount the wheel back and place the vehicle on its wheels. The control arm bolt should be tightened according to the manufacturer's specification while the suspension is under load (the car stands on wheels). Afterwards, mount the bolt covers and engine cover back to the vehicle.
