Manual

Replacement of rear crossmember bushing with **TEDGUM® TED48027**

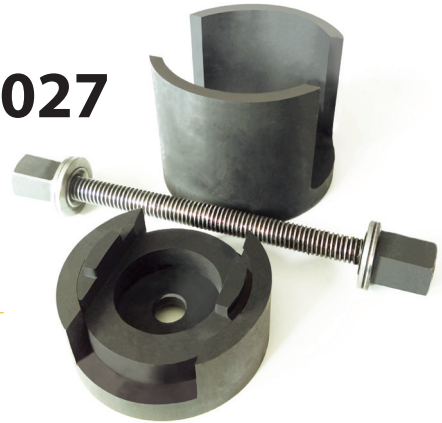
The puller is designed to enable correct replacement of bushing directly on the car without the need of rear crossmember removal. High durability was achieved thanks to trapezoidal thread. Appropriate lubrication of bolt thread and bearing is crucial to guarantee best performance and durability of the tool. The lubricant is included.
